# Manhole Inspection Summary

Manhole # S57A\_\_015MH

Insp Date: **7/28/08 10:20 AM**

**Location** Address: **4101 pulaski hw**

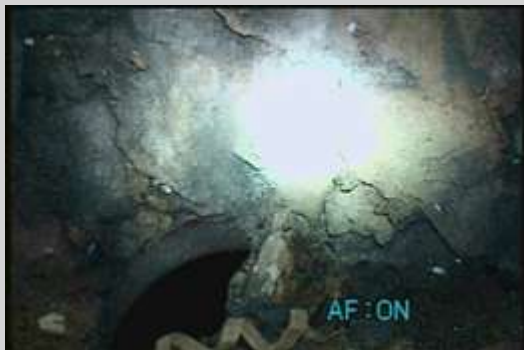
12 O'Clock Outflow

8 in. Circular Gravity Sewer  
Pipe Out @ 12 O'Clock

to much debris for good shot
